Reviewed Article:

The Butser Ancient Farm Horton Neolithic Building – Its Construction and Significance to the Interpretation of Buildings of Early Neolithic Britain and Ireland

Author(s): Trevor Creighton ¹

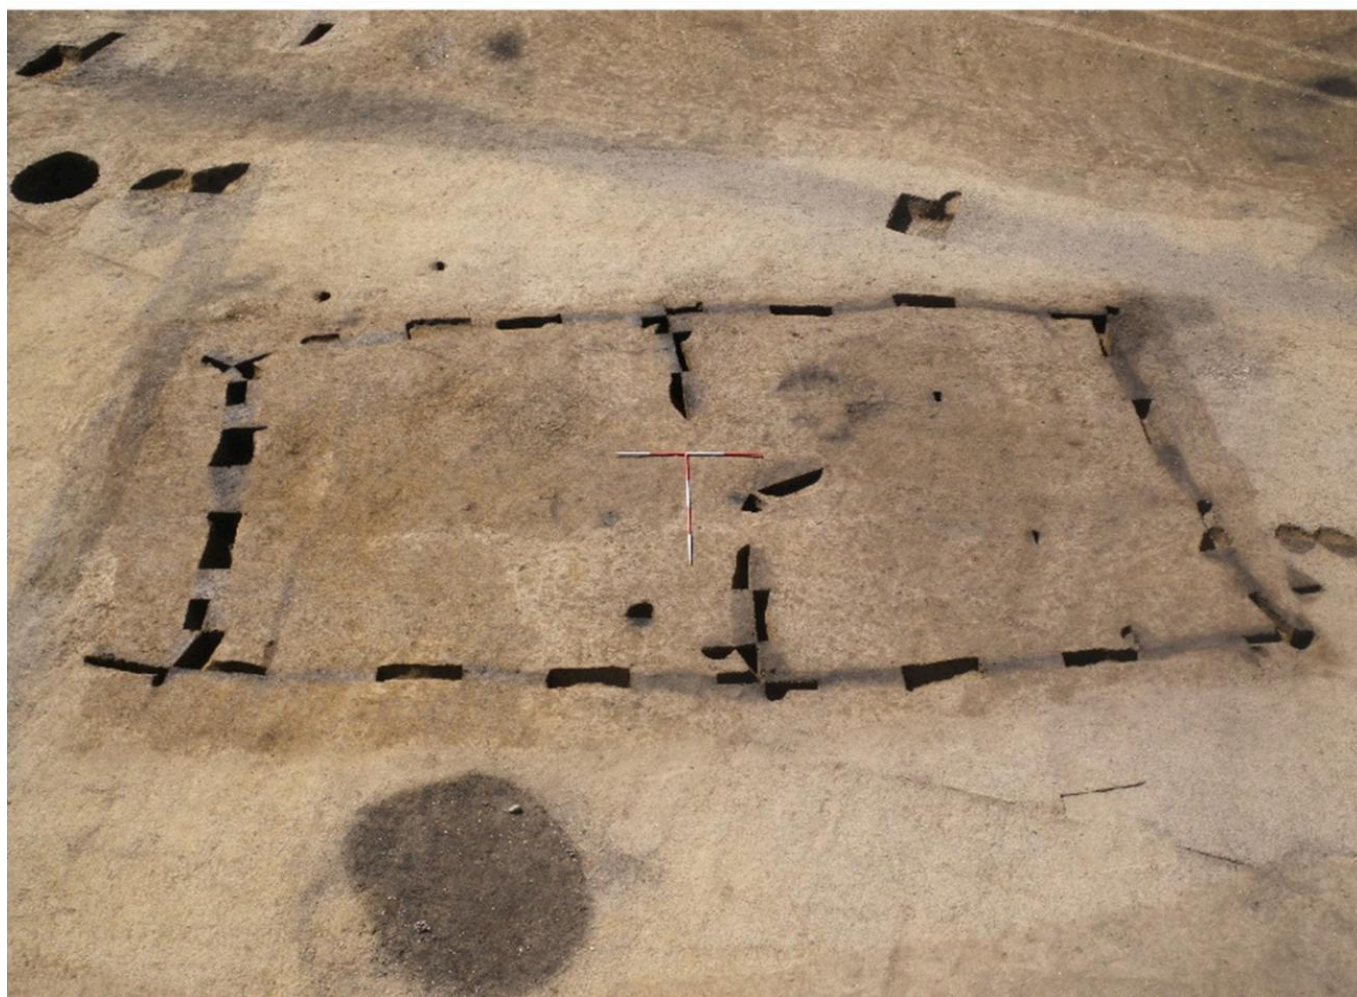
FIG 1. THE HORTON 2 ARCHAEOLOGY DURING EXCAVATION. PHOTOGRAPH COURTESY OF WESSEX ARCHAEOLOGY.

The archaeology presented as a slightly bow-sided rectangle of trenched foundations, filled with dark organic material that contrasted well against the natural (See Figure 1). In the excavator's report the structure was identified as 'House 34500' and is characterised in this paper as 'Horton 2' (Wessex Archaeology 2013, p.12.). The associated pottery indicated an Early Neolithic date of 3750 BCE (Wessex Archaeology, 2013, p. 31; Wessex Archaeology, n.d.). The structure was loosely rectangular in plan and contained an internal partition dividing it into two rooms/cells. The house is thought to have been constructed of upright posts or planks placed in foundation trenches' (Wessex Archaeology 2013, p. x). Its breadth varied between 6.1 to 7.7 metres, with a length of 15.06 metres. A pair of discontinuities in the foundation trenches at the southeastern corner of the archaeology, approximately 1 metre wide and separated by a feature suggestive of a timber partition also about 1 metre wide, were interpreted as doorways (See Figures 1 and 6). The excavators also observed that the archaeology 'bore a striking resemblance to the Early Neolithic house found during the 2008 excavations' at the same site (Wessex Archaeology 2013, p. x).

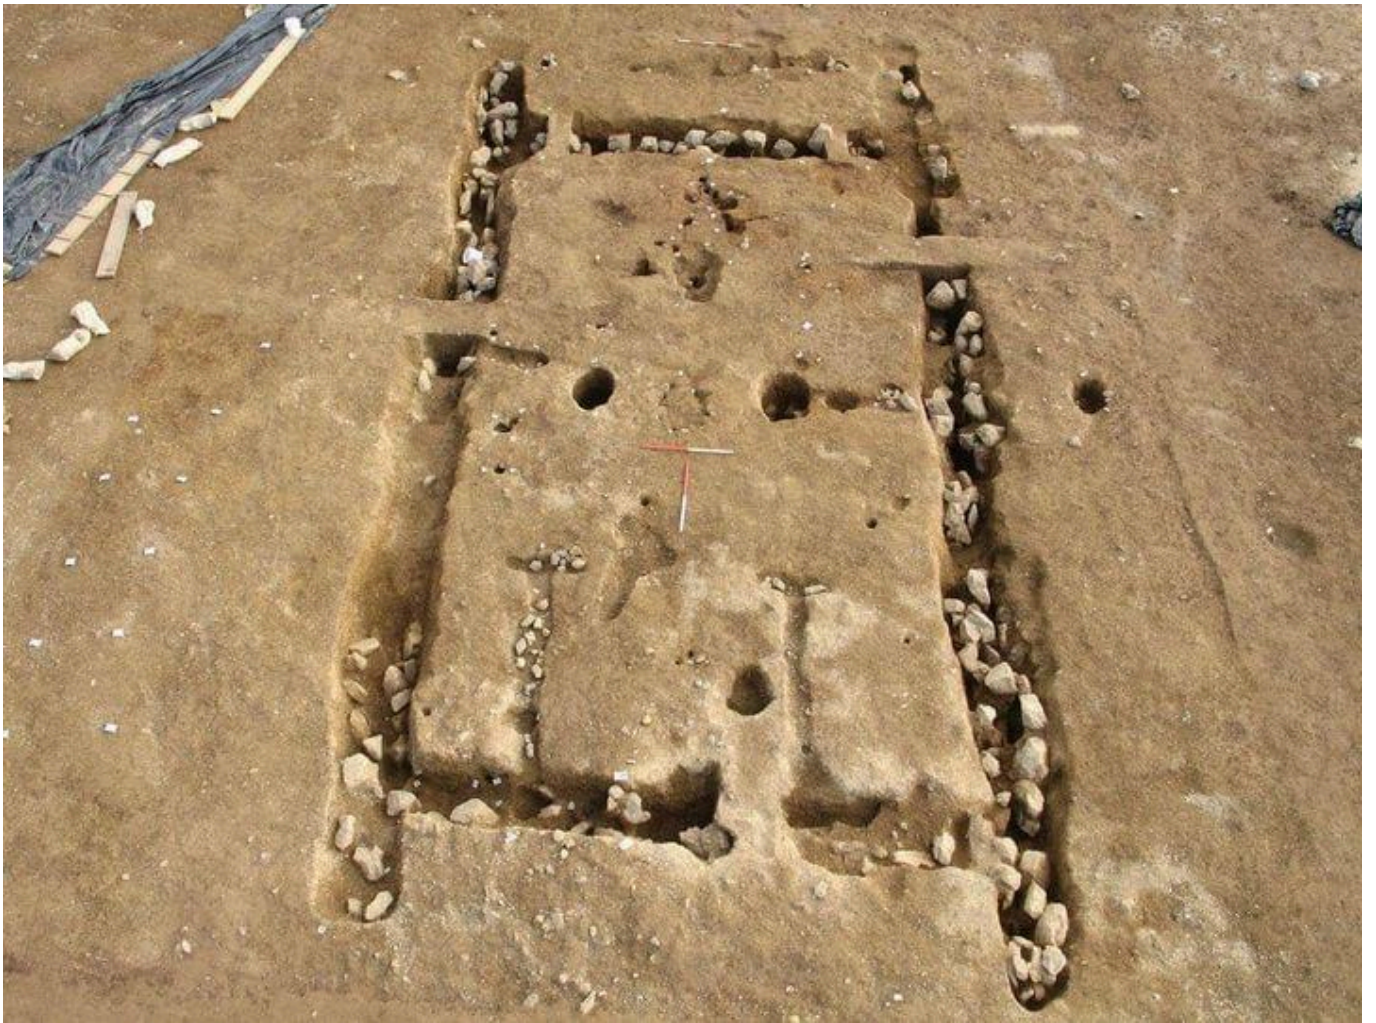
FIG 2. DUNSINANE IRELAND. USED WITH KIND PERMISSION OF TVAS LTD. IRELAND.

Structures of comparable ground plan have also been recorded in Ireland. Sites at which structures that exhibit morphological similarities to the Horton 2 archaeology have been excavated include numerous Irish examples, such as Mullaghbuoy, Ballintaggart, Dunsinane (See Figure 2), Ballygally, Ballyharry, Russelstown, Kishoge, Ballysaxhills and Drumenny (Smyth, 2013; Smyth and O'Flaherty, 2015). It is possible that a large Neolithic structure excavated in 2021 at Clooney Road, outside Derry City, by Northern Archaeology Consultancy is yet another example of the type, but the report has not been published at the time of writing (McMonagle, 2023, pers. com.). In all cases, the structures are dated to the first third of the Irish and British Neolithic (ca. 3900 – 3600 BCE). There appear to be no exact parallels in construction antecedent to or after this period. In the case of both Horton structures, and a number of those from Ireland, distinctive projections are in evidence at either, or in some cases perhaps both, ends. These take the form of continuations of the trench foundations of the longer sides beyond their intersections with the foundations of the shorter sides (See Figures 1 and 6). Breaks in wall trenches along one or other of the long axes, generally interpreted as entrances, are also often apparent in the archaeology (Smyth and O'Flaherty 2015, pp. 13 – 14). The archaeology of these structures also exhibits substantial slot trenches that extend into the interior spaces from the mid points of the long axis foundation trenches. These form what appear to be dividing walls at the centres of the structures (See Figures 1, 2 and 6). In each case these putative internal dividing walls are discontinuous, with a break in their centres, presumably to allow access to both ends of the structures. Such specific morphological similarities are suggestive of a 'type', and one of unusual form and dimension

The repetition of the Horton Type ground plan at multiple sites across Britain and Ireland, the chronologies of which are restricted to a relatively short period spanning approximately 3900 – 3600 BCE, raises questions about how the Type arose, apparently without obvious precursors, and why it disappeared so rapidly (Smyth and O'Flaherty, 2015, p. 14). The original Horton 2 foundations are quite massive and suggest that the structure was conspicuous in its consumption of walling materials, a pattern that appears common to other buildings of the Type, for example at Dunsinane (See Figure 2).

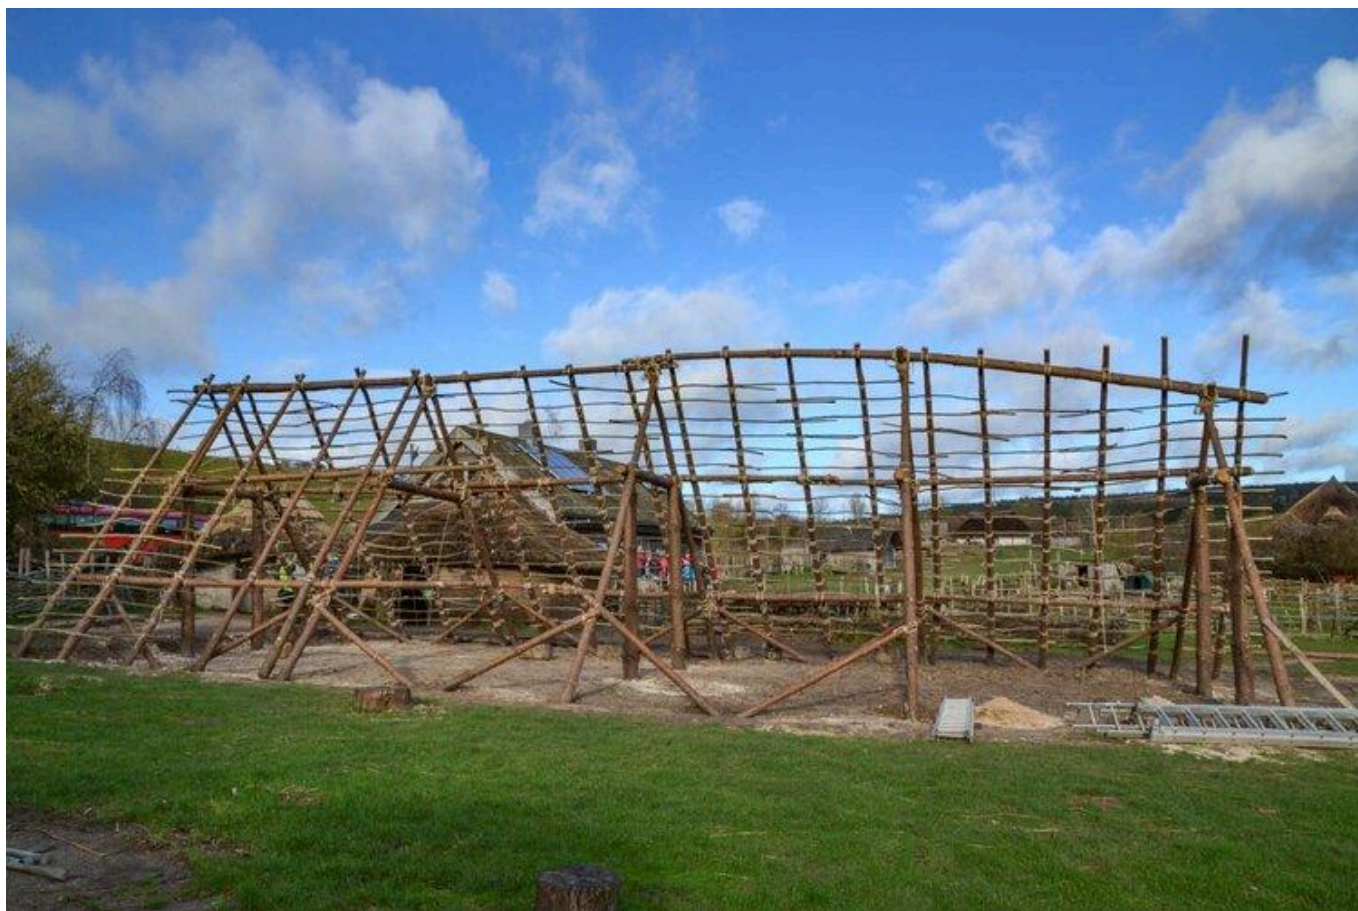
FIG 4. NEAR COMPLETE FRAME OF THE HORTON 2 HOUSE AT BUTSER ANCIENT FARM. PHOTO BY TREVOR CREIGHTON 2019.

Two rows of horizontal purlins (created using multiple ca. 5m poles lashed end to end to create a continuous length) were fixed to the load-bearing principal rafters along both sides of the long axis of the structure. One row was fastened approximately 1m from the ground, another at approximately 3m. The purlins carried paired common rafters, set approximately 1m apart along the long axis of the building (See Figure 4). Hazel rods, running laterally, were lashed to the common rafters and acted as battens to which water reed thatch was attached using lashed twine (See Figures 3, 4 and 5).

A series of earth-fast poles were attached laterally to the principal rafters, at a height of approximately 1 metre and an angle of 45° and set within the ground to act as lateral bracing (See Figure 4).

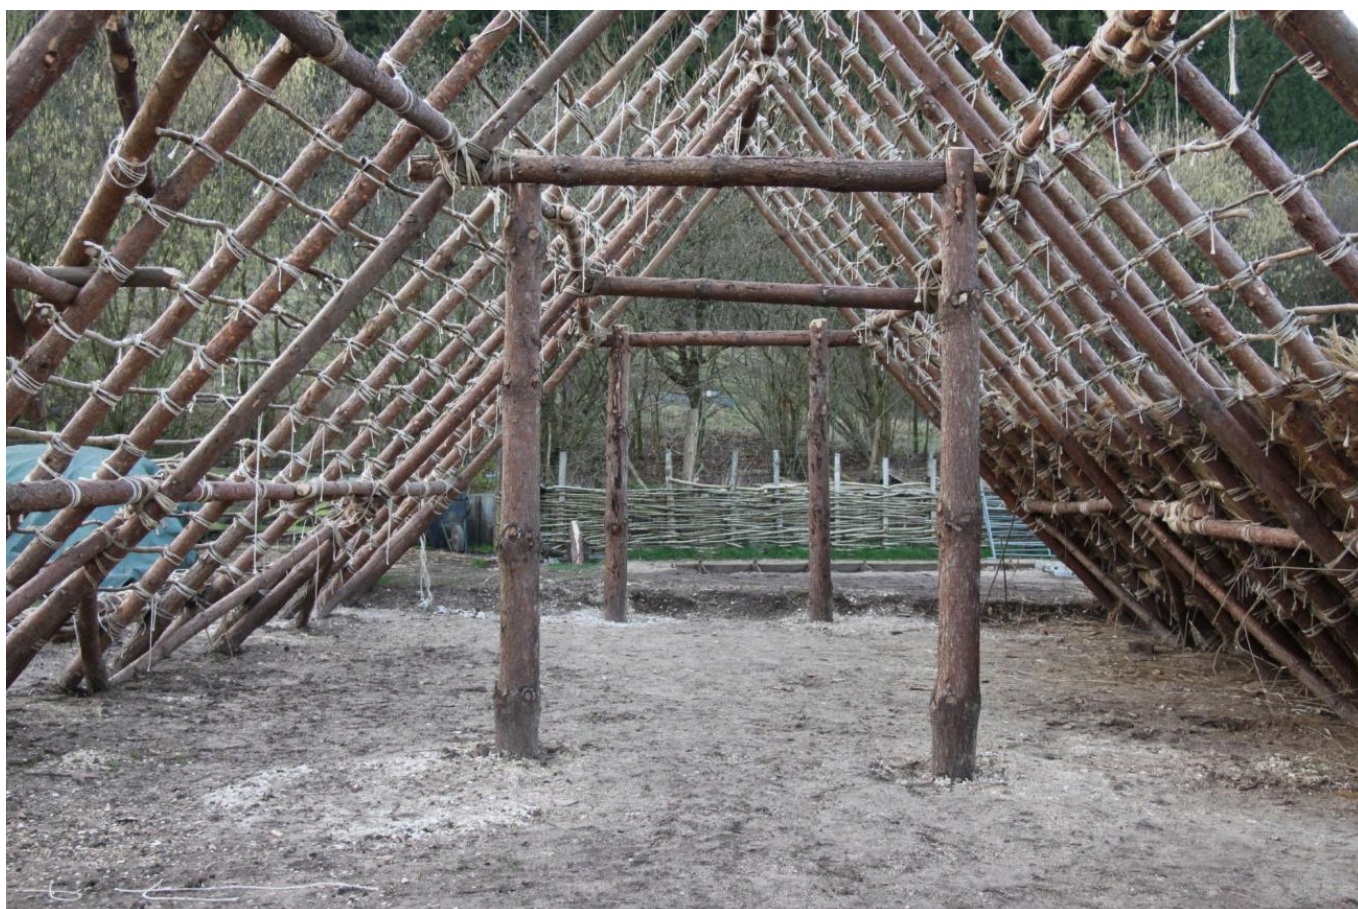
FIG 5. INTERIOR OF HORTON 2 NEOLITHIC HOUSE AT BUTSER ANCIENT FARM LOOKING WEST. UNDER CONSTRUCTION, SHOWING CENTRAL, UPRIGHT INTERNAL POSTS IN CENTRE OF BUILDING AND AT THE WESTERN END. PHOTO BY TREVOR CREIGHTON 2019.

The solution developed at Butser Ancient Farm was to eliminate structural walls and employing instead an A-frame construction with five principal earth-fast rafters, each pair braced by an elevated tie-beam (See Figure 5). The principal rafters are distributed

Elevated tie beams spanned the internal void, secured at each of their ends to the five principal rafters. The tie beams at either end of the structure were supported by a pair of upright, earth-fast posts. A similar configuration was employed in the centre of the building, at the terminal points of the innermost ends of what had been identified in the archaeology as the central dividing trenches (See Figure 5). Discussions with the excavating archaeologists concluded that posts may have been present at these points in the archaeology (as they are in some Irish examples. See Smyth 2013, p. 304), although this is a tentative suggestion (Chaffey, 2019, pers. com.). A pair of partial dividing walls were set within the building, mirroring the archaeology, which in our interpretation are non-load-bearing partitions. They
