Unreviewed Mixed Matters Article:

Building Rome in a Couple Days: Erecting a Painted Portico in Alésia

EXARC Journal Issue 2025/3 | Publication Date: 2025-11-20

Author(s): Nicolas Revert ¹ ✉

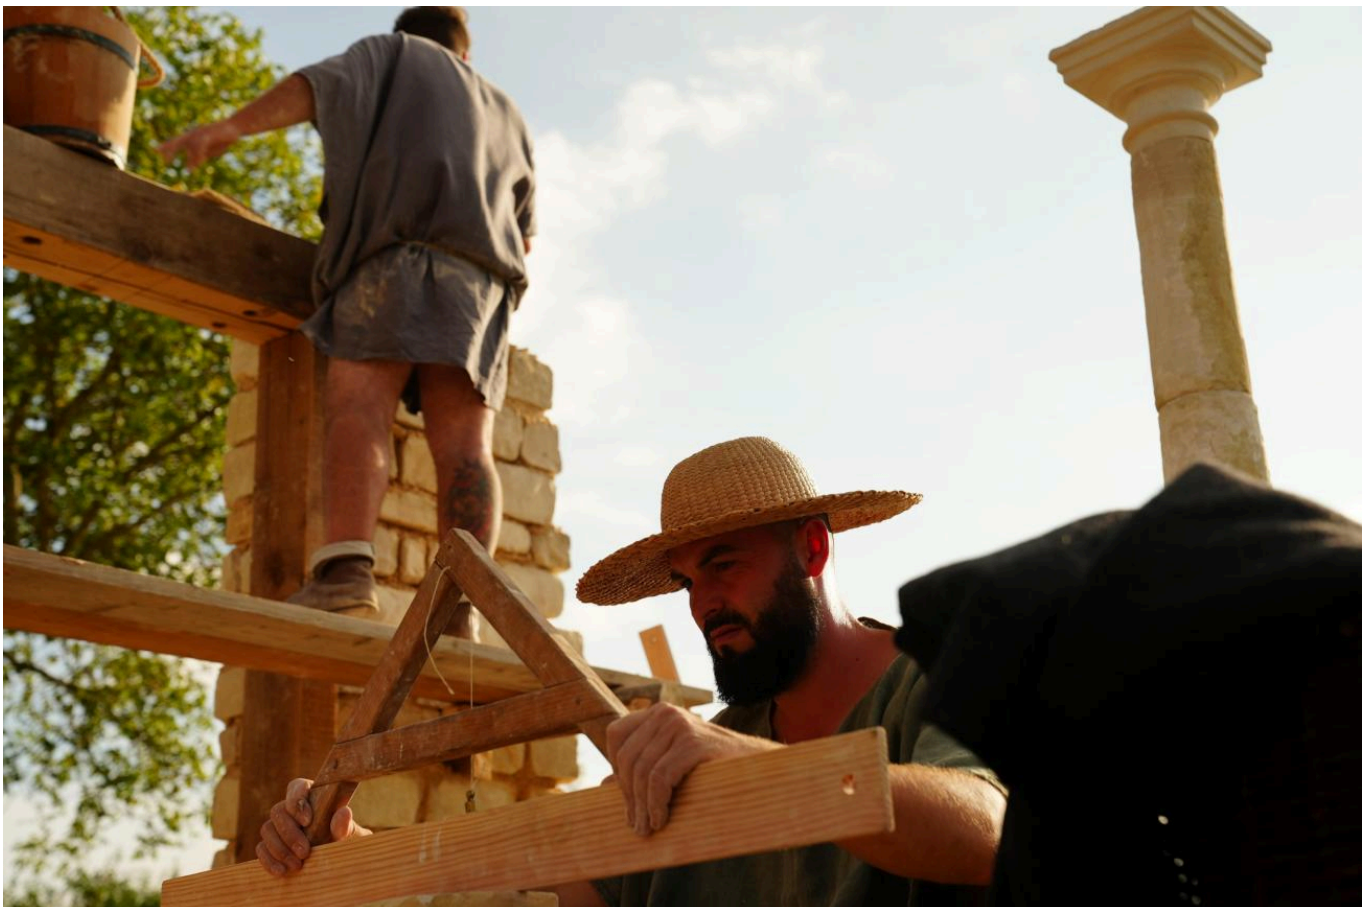
FIG 1. THE LIBELLA BEING USED TO CHECK THE HORIZONTALITY OF THE GROUND ON WHICH COLUMNS ARE BUILT. PHOTO BY ALEXANDRE BOULOUMOU.

Being located inside an archaeological site, it was impossible to dig trenches for the foundations. The ground was simply levelled with some wet sand, creating enough support for the temporary construction. The horizontality of the sand strata was checked with a plank and a *libella*, the roman *archipendulum* which employs a plumb line (See Figure 1). Then, the threshold - a large slab of limestone - was set into place, and levelled as well, using mallets to correct its slope. Following this, two pieces of string were fixed to simple wooden sticks, inserted into the ground, which allowed for the construction of the 2.50 m long portion of the wall and its width of 0.45 m. The walls had to be 2.70 m high, exceeding the height of the columns, to accommodate and envelop the tie beams of the semi-truss frame. The wall was only interrupted where the 2 m tall doorway was located.

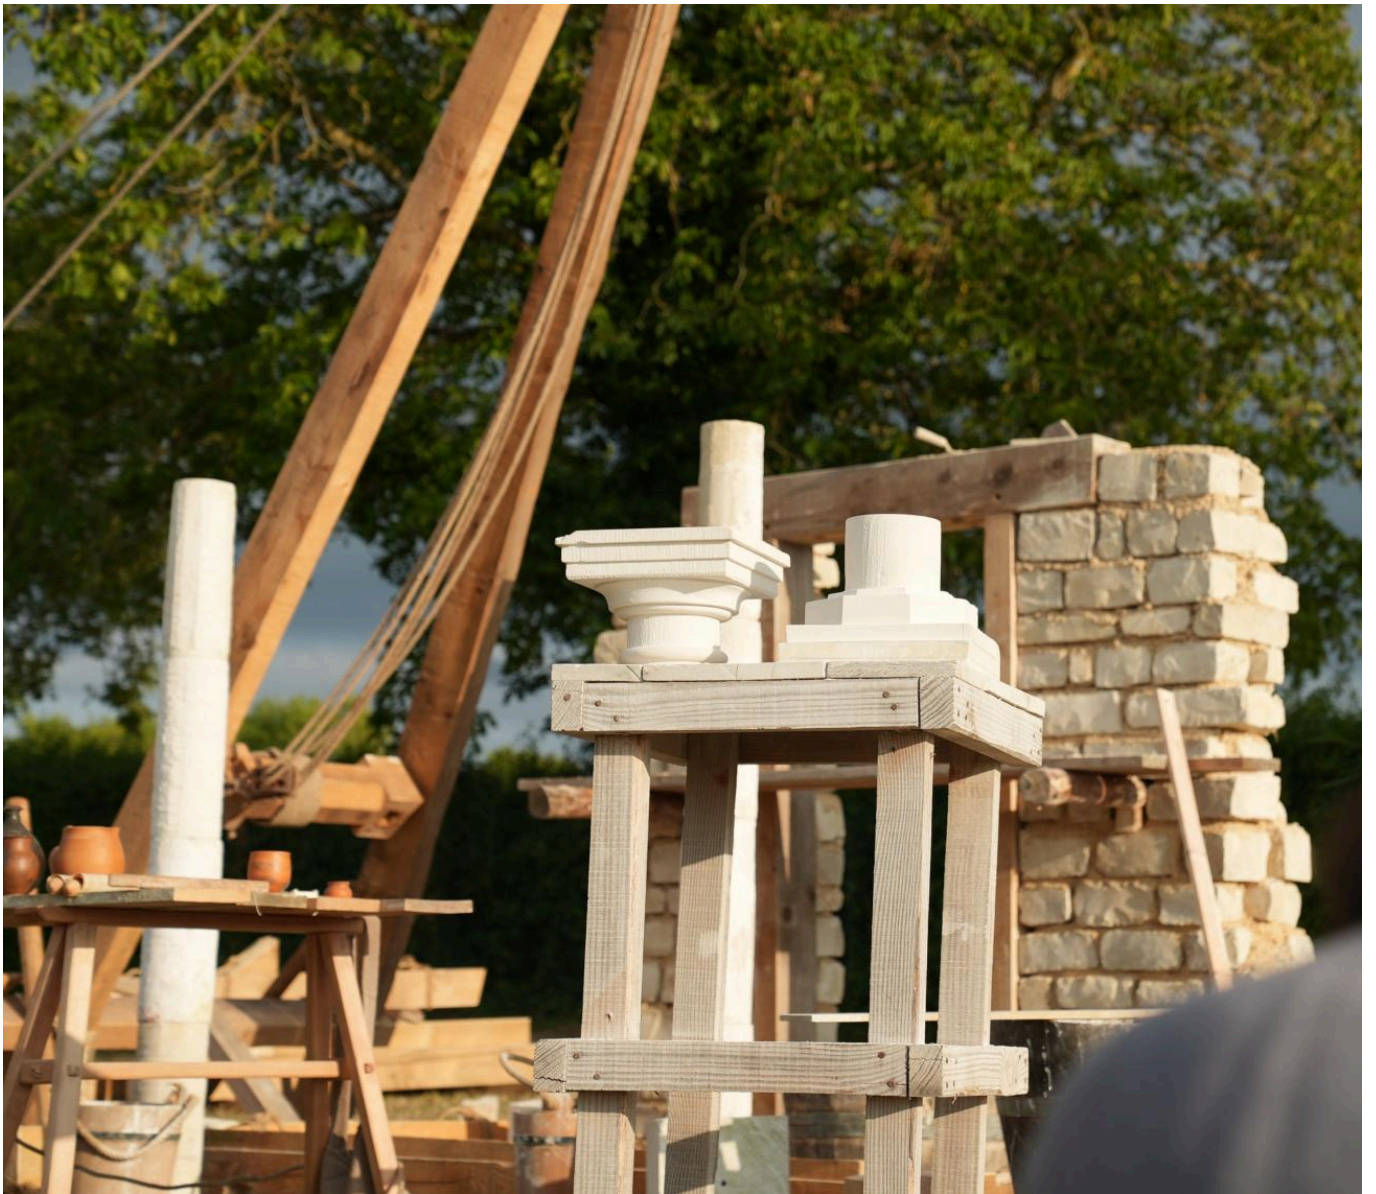
FIG 2. THE TWO CAPITALS BEING MADE BY THE STONECUTTER, WITH THE PORTICO ENTRYWAY IN THE BACK.
PHOTO BY ALEXANDRE BOULOUMOU.

Two meters away from the wall, two columns were put into place, using the same rudimentary footing of wet sand as for the walls. These columns were carved from a finer grained limestone, also from the Saintonge area, specifically from the Thénac quarries, in operation since the roman period (Gaillard 2004). They comprise four slender drums, each 0.50 m high, varying from 0.18 to 0.20 m in thickness. They support two capitals, one of the provincial Tuscan order and the other one of the doric order (See Figure 2), which are prevalent at Alésia (Olivier 2021). These blocks were all carved with chisels and facing hammers, as well as turned on the lathe, except for the capitals. The stone-turning technology, well documented throughout the Roman Empire, is extremely frequent in Alésia. Indeed, nearly all the archaeological capitals and shafts display characteristic marks on the stone: circular grooves and ridges, as well as square mortises in the upper and lower ends of the blocks, used for inserting the lathe's mechanism (Gaillard *et al.* 2019; Revert & Brigaud 2022). On the topic of this specific technology, a paper was presented during the 13th Experimental Archaeology Conference in Torun, Poland (Revert & Brigaud 2023). Using the lifting crane, we could hoist the blocks and assemble the columns. Because of the added weight on such small bases of wet sand, the right-hand column leaned on the right, where the slope was the most noticeable. While this did not end in utter failure, it is certain that a more stable footing, or even foundations, are necessary for the stability of such supporting architectures.

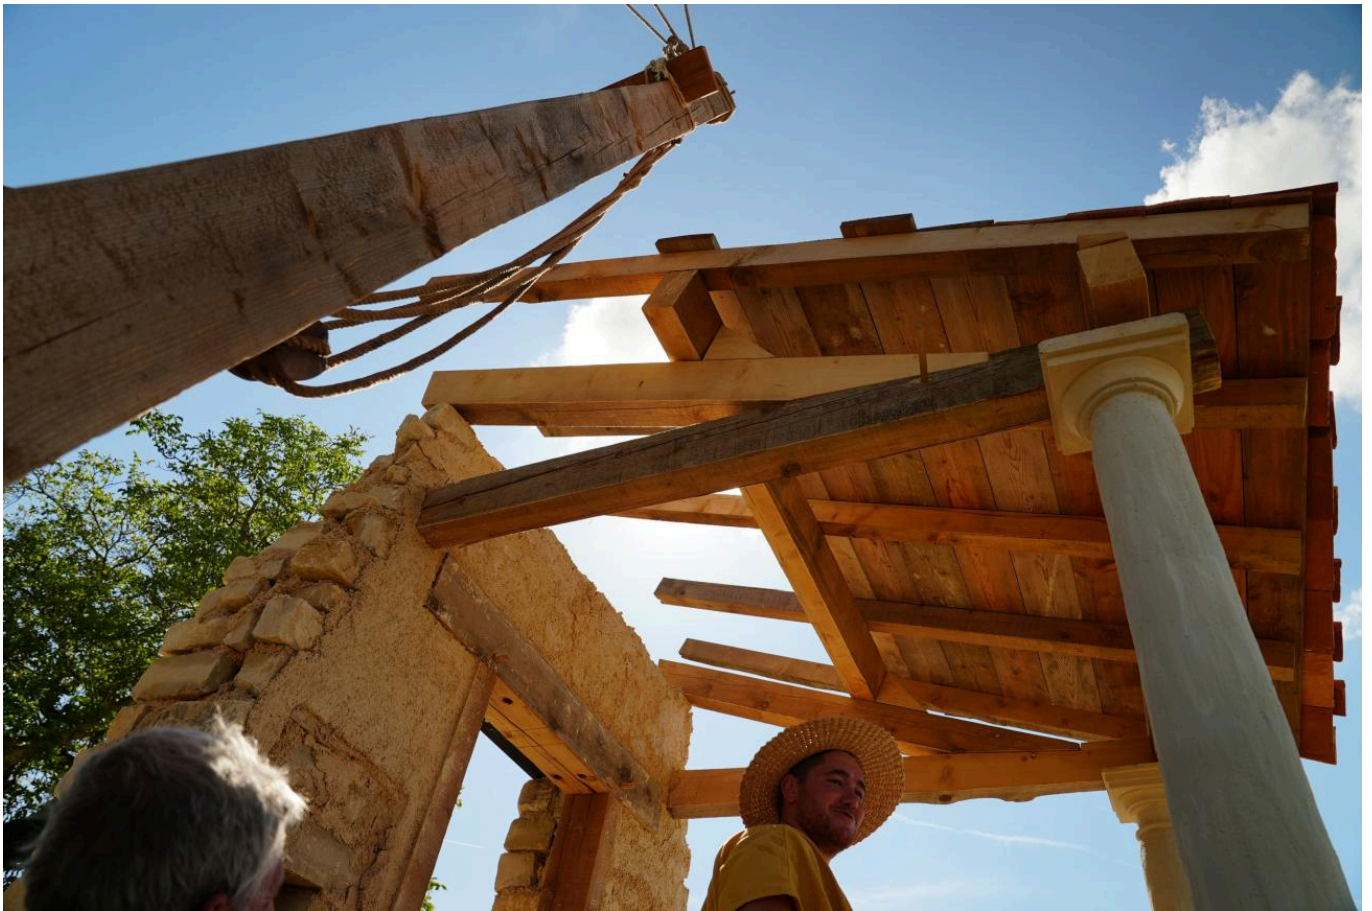
FIG 3. THE COMPLETE TIMBER FRAME, SITTING ON TOP OF THE COLUMNS AND THE FINISHED WALL. PHOTO BY ALEXANDRE BOULOUMOU.

The different parts of the timber frame were already produced by the carpenter beforehand, as it is a very time-consuming process. Only the assembly and a few minute adjustments had to be carried out on the building site. First, the two tie beams were inserted into the holes left open in the wall and were supported at the other end by the columns (See Figure 3). Notches on the upper part of the tie beams were cut to receive the heavy high wall plate, also bearing identical notches. This assembly is called a halved joint. The tie beams also support two crossbeams, sitting directly on the wall in one end, and assembled with the beams with a front tie-backs joint, coupled with a mortise and tenon joint, secured with wooden pegs. The ends of the crossbeams were not cut off, as it would have prevented the disassembly of the whole timber frame. This robust foundation could support a wall plate, which simply sat on the crossbeams and was kept in place with a nailed wedge. The five rafters were also nailed to the high wall plate and the wall plate. Lastly, the plank battens simply sat on the rafters, as the structure was temporary, and the roof's slope only had a slight incline.

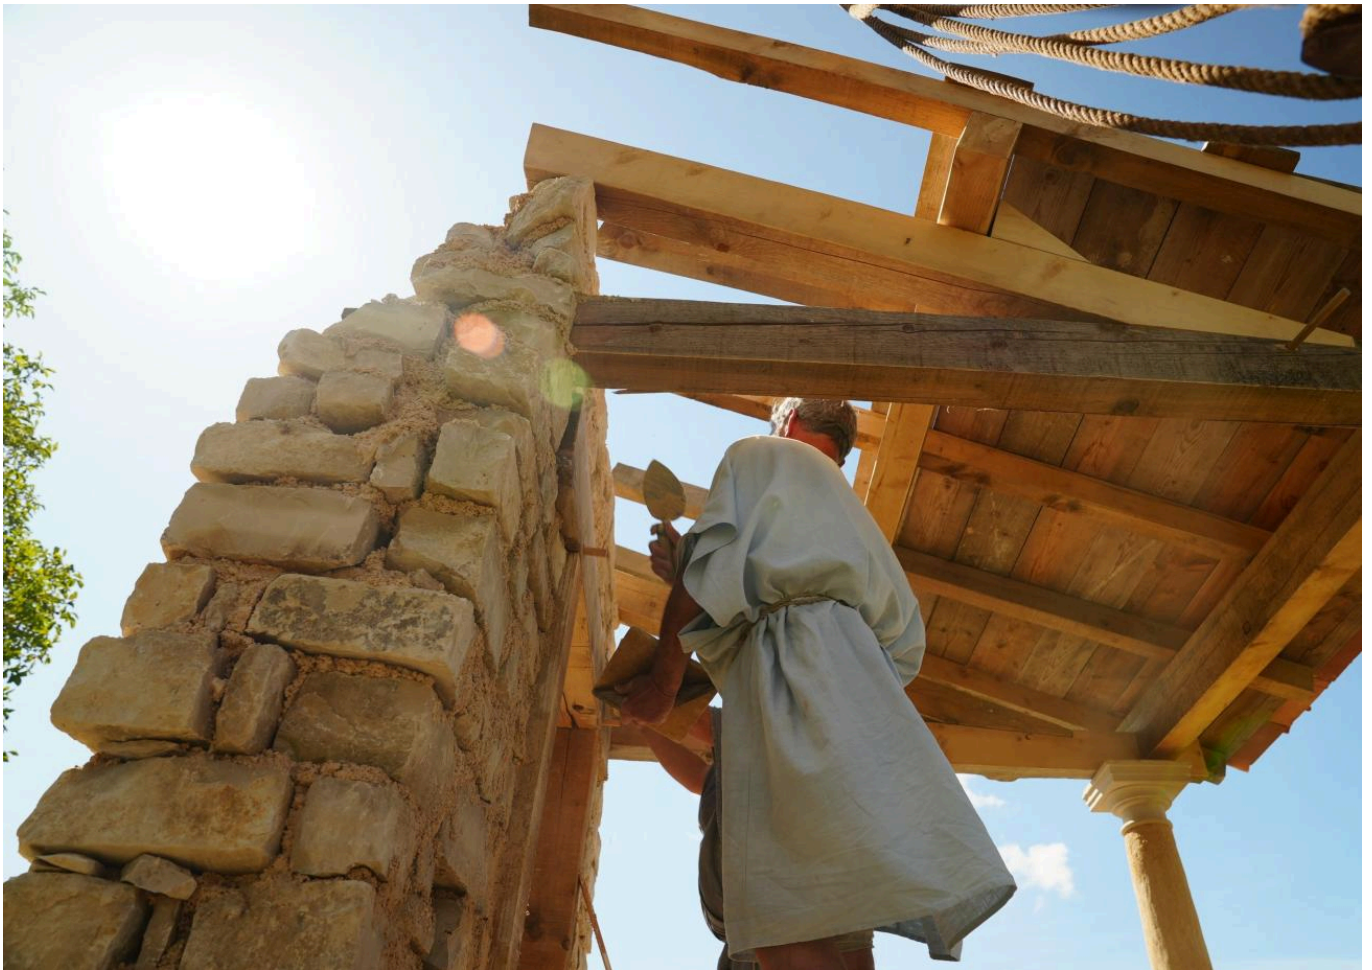
FIG 4. THE MASONS ARE PROJECTING MORTAR PLASTER ON THE WET SURFACE OF THE WALL. PHOTO BY ALEXANDRE BOULOUMOU.

Before plastering, the wall of the portico had to be dampened with water, as it is needed for the plaster to adhere securely to the wall. The plaster is a simple sand and lime mortar, of a finer grain than previously employed for the construction of the wall. Using a float and a trowel, the masons sprayed the mortar on the wall, ensuring that all grooves and holes are filled in a swift and efficient movement (See Figure 4). The columns were plastered similarly,

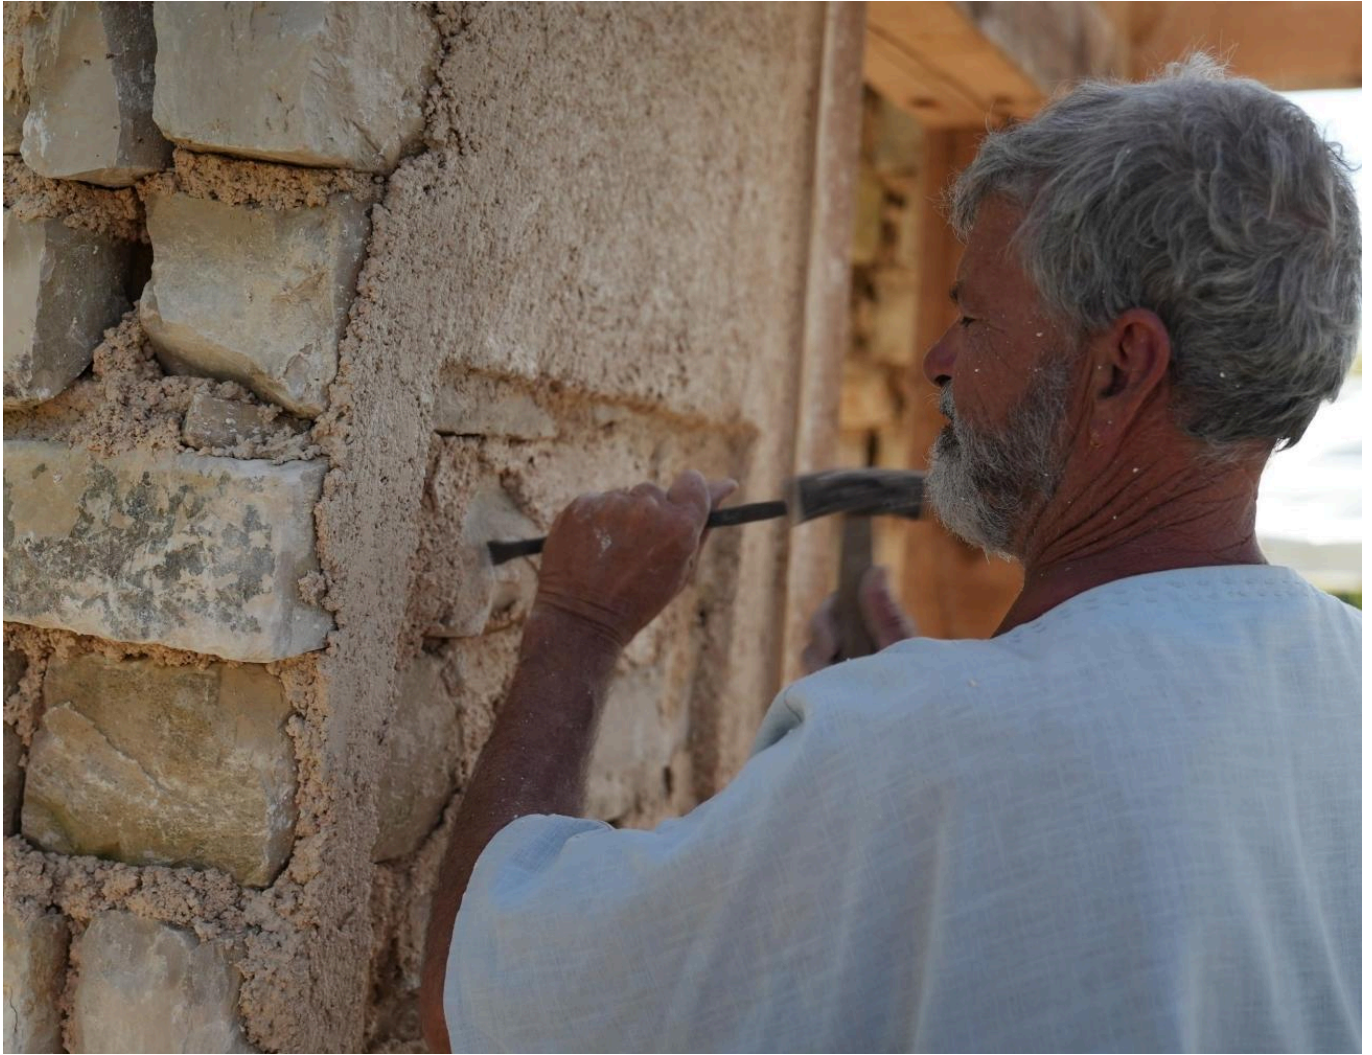
FIG 5. THE MASON IS REMOVING PROTRUDING PARTS OF THE STONES, SO THAT THE PAINTINGS CAN BE INSERTED CORRECTLY. PHOTO BY ALEXANDRE BOULOUMOU.

before being smoothened with trowels and planks. The latter also serve to measure the regularity of the plaster surfaces. Square recesses were left partially plastered, as they would receive the two paintings (See Figure 5).

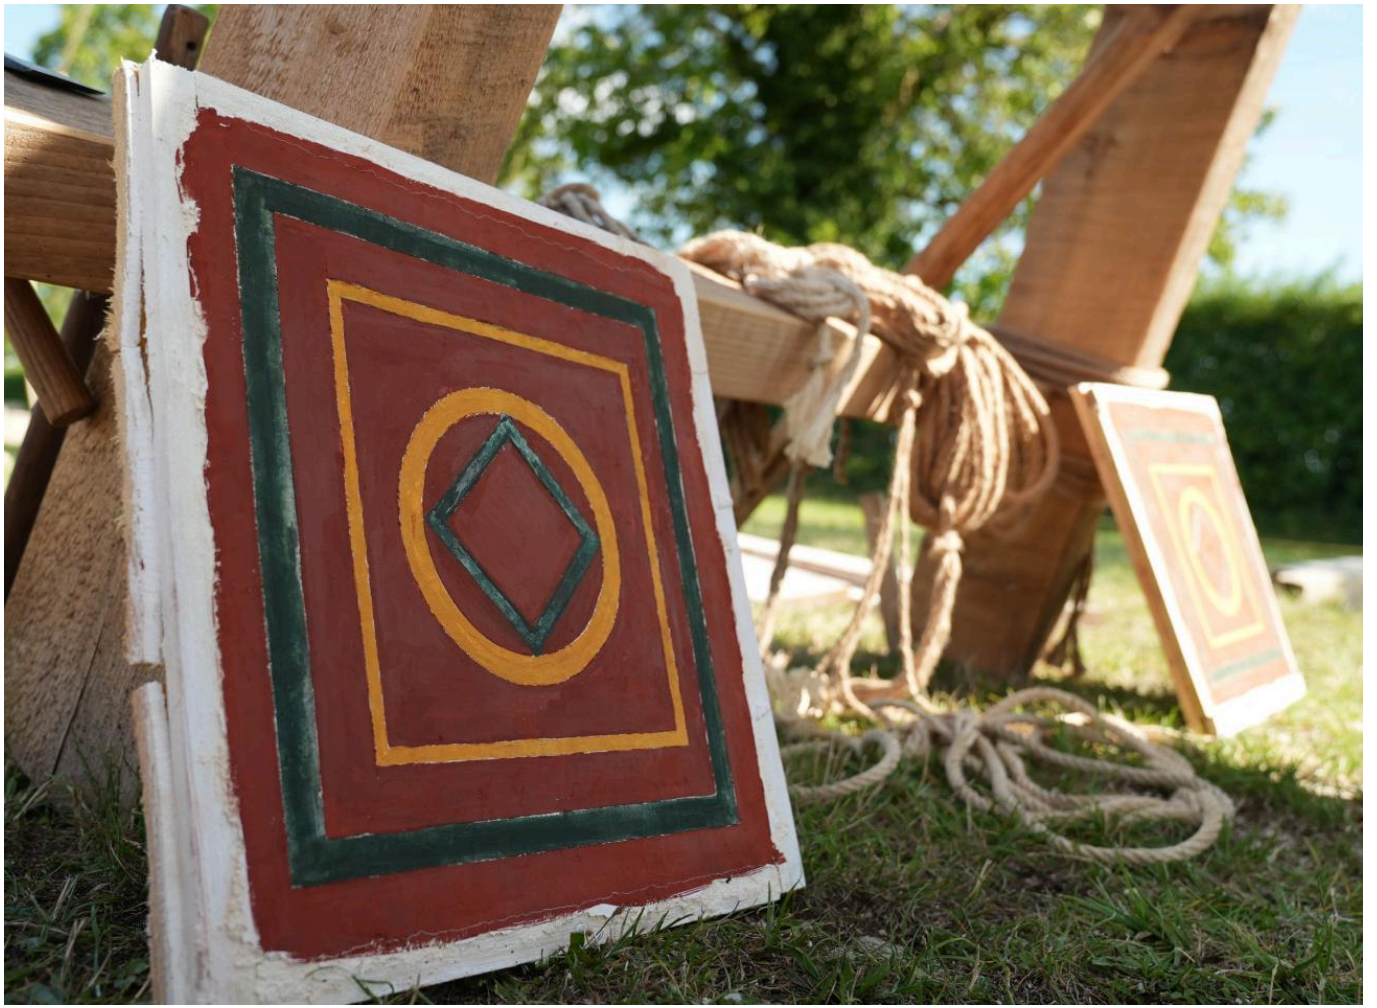
FIG 6. BOTH PINAKES DRYING AFTER HAVING BEEN PAINTED. PHOTO BY ALEXANDRE BOULOUMOU.

Indeed, while all the previous building steps were carried out, the *pictor*/painter was making two *pinakes*, i.e. painted plasters in a wooden frame (See Figure 6). These delicate elements require several coats of mortar, from a coarse-grained plaster like the one used to plaster the wall and columns, to a finer mortar containing sieved sand, and finally a very thin coat of "marble" plaster, containing sieved lime and finely ground limestone. This last coat is polished finely with small trowels and spatulas to create a smooth surface for the final painting. This up-to-six-coats process can be seen in most archaeological painted plasters, especially when displaying intricate motifs. After being etched into the final coat of the plaster, the painting is carried out with brushes and a wooden plate. The pigments do not need a binder, as the fresh plaster coats will allow for adhesion with the minerals and set permanently after drying. The pigments are mixtures of fired ochres, coal, malachite or other minerals, depending on the colours needed. As there was a lot of wind during the event, the plaster dried very quickly, which prevented the pigments to adhere as well as would have been necessary to recreate an authentic *pinax*. Nonetheless, the whole process was deemed satisfactory, with very few details having to be corrected during later experiments.

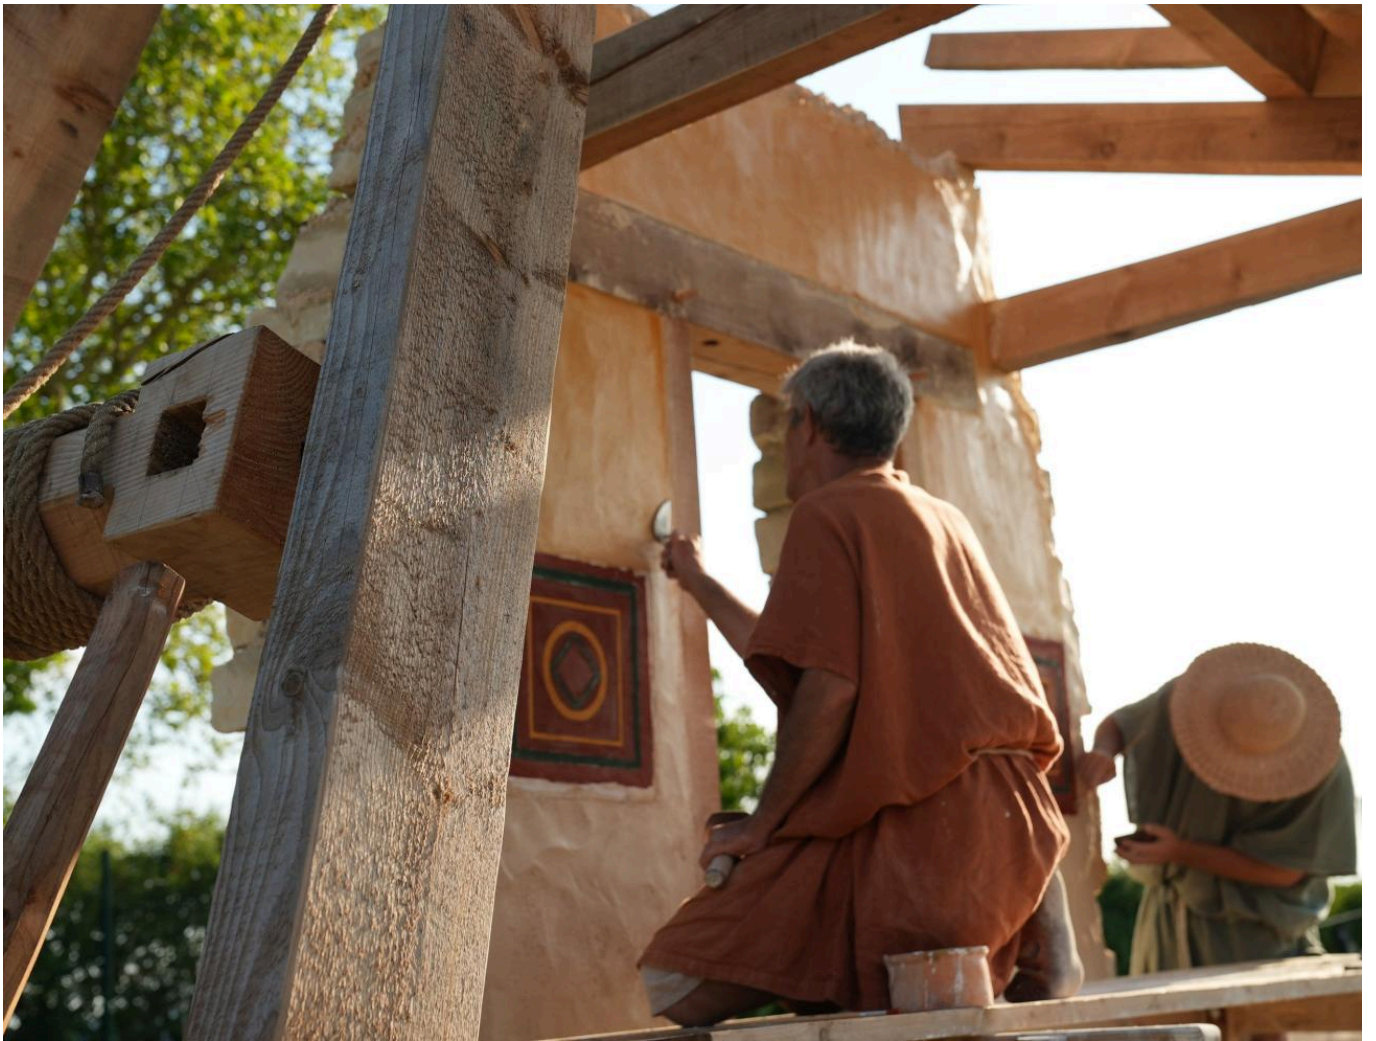
FIG 7. THE PAINTER SMOOTHES THE SURFACE OF THE FINAL PLASTER COAT, TO COVER UP THE WOODEN FRAME OF THE PAINTED PINAKES. PHOTO BY ALEXANDRE BOULOUMOU.

After being inserted into the wall recesses, the wooden frame of the *pinakes* was also covered in plaster (See Figure 7), as has been found in some of the best-preserved wall paintings in Pompei (Allag & Barbet 1972, 981-83; Mora *et al.* 1977, 122-23; Adam 2017, 240). The last task of the entire construction was the painting of the entire wall and the columns, whose lower parts were painted in red ochre while the upper columns were painted in white, and the upper walls in yellow. These simple motifs were painted swiftly with wide brush strokes, adequate for exteriors. Thus, the construction was finished (See Figure 8).

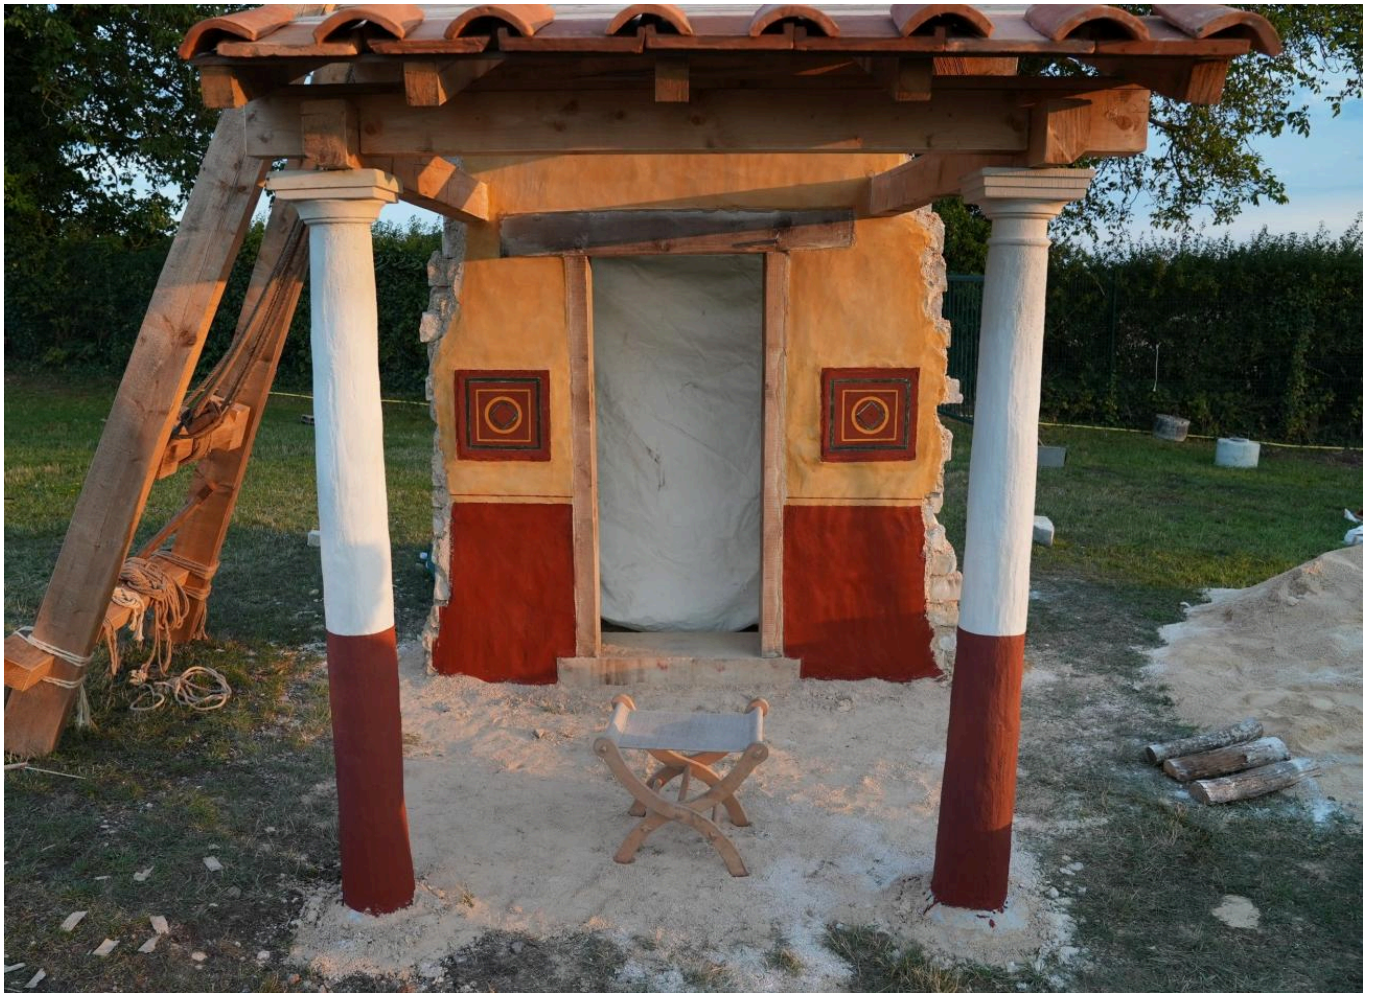
FIG 8. THE FINAL PORTICOED ENTRYWAY. PHOTO BY ALEXANDRE BOULOUMOU.
