EXARC JOURNAL 2020/2
18 Articles | Open Access

Roar Ege: The Lifecycle of a Reconstructed Viking Ship

Author(s): Tríona Sørensen [1] ✉, Martin Rodevad Dael [1]

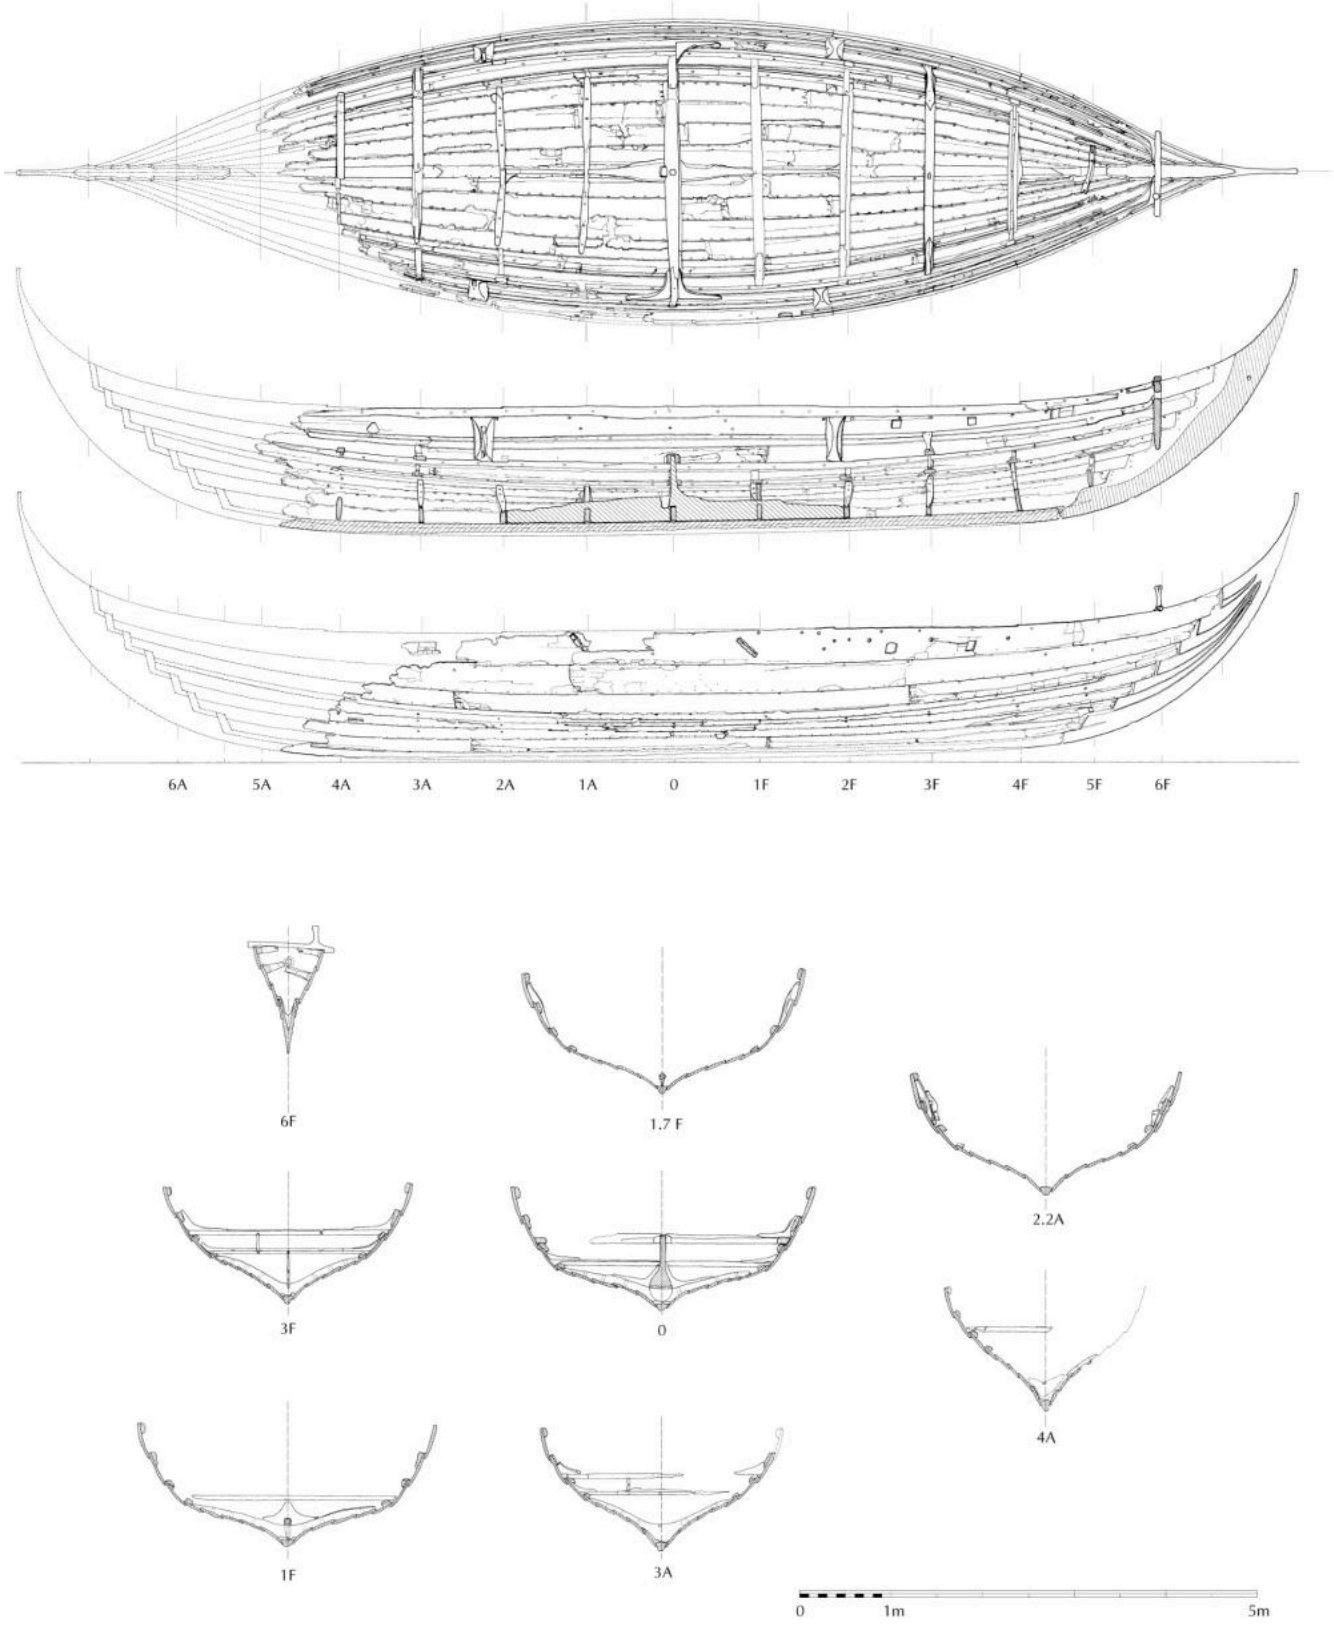
FIG 3. TORSO-DRAWING OF ALL PRESERVED PARTS OF THE SHIP-FIND, SKULDELEV 3, ASSEMBLED TO THEIR ORIGINAL CONTEXT AND SHAPE (AFTER CRUMLIN-PEDERSEN AND OLSEN 2002, 229, FIG. 40).

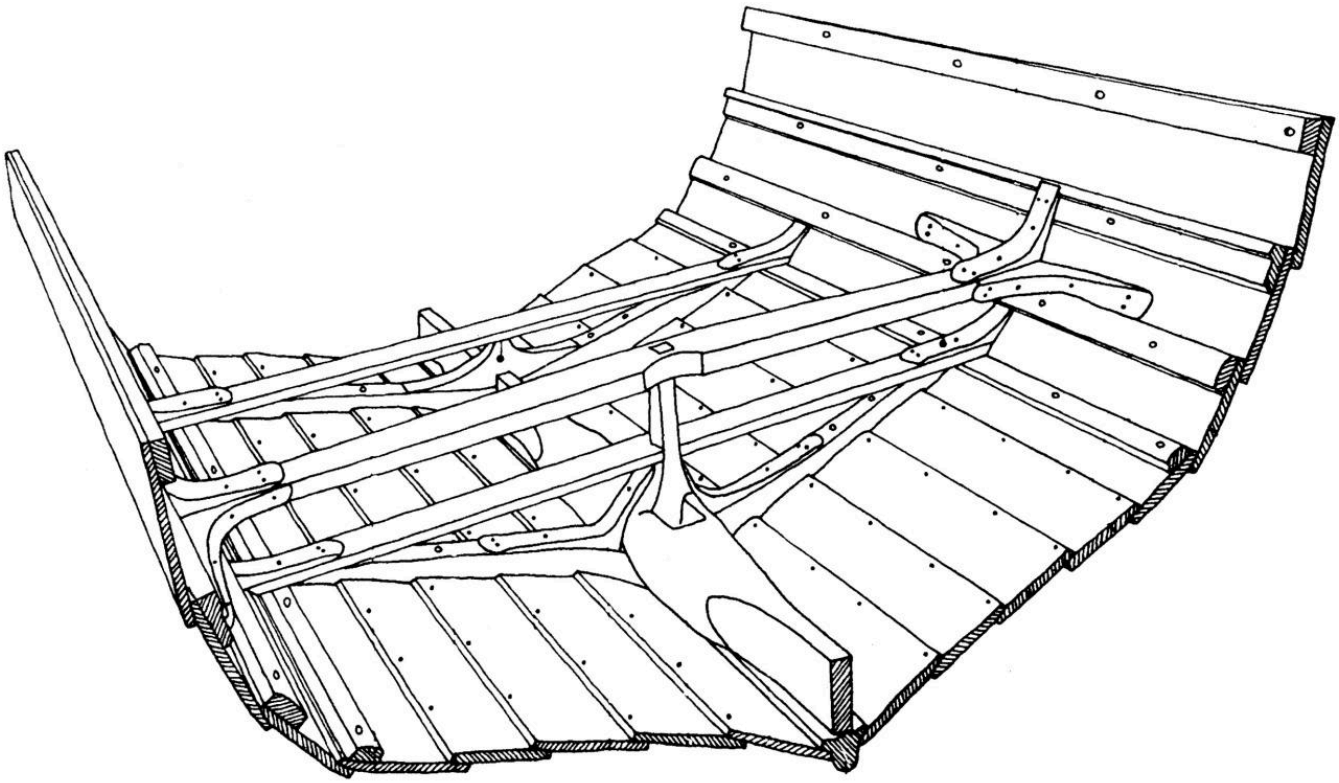
This repair encapsulates one of the major challenges associated with maintaining clinker-built boats. Clinker-built boats are constructed using a technique where boards and other components overlap each other (See Figure 8). Even with regular care, maintenance and cleaning, these overlaps can create ideal conditions for rot. Of particular note here are the longitudinal reinforcing timbers – the stringers. Clinker-built ships are designed to have a degree of flexibility – this is one of the advantages of the method as it allows for light constructions which can take a considerable beating when at sea. The downside of this flexibility is that components – such as the stringers – which are only fastened using treenails, can work themselves loose over time. This creates gaps between components, trapping moisture and organic matter between the contact surfaces of the stringers and the boards they are fastened to, facilitating the growth and spread of rot. The outer shell of the hull, which is comprised of overlapping boards is not affected by rot in the same way. The land, or overlap, between the boards is caulked using tar and wool, and this helps to exclude moisture from the joint. Where planking material has become subject to damage from rot, it has generally been because it started in the internal stringers and then spread to the surrounding planking material.

FIG 8. RECONSTRUCTED CROSS-SECTION OF SKULDELEV 3, SHOWING THE MANNER IN WHICH THE VARIOUS COMPONENTS OVERLAP EACH OTHER (AFTER CRUMLIN-PEDERSEN AND OLSEN 2002, 198, FIG. 3).

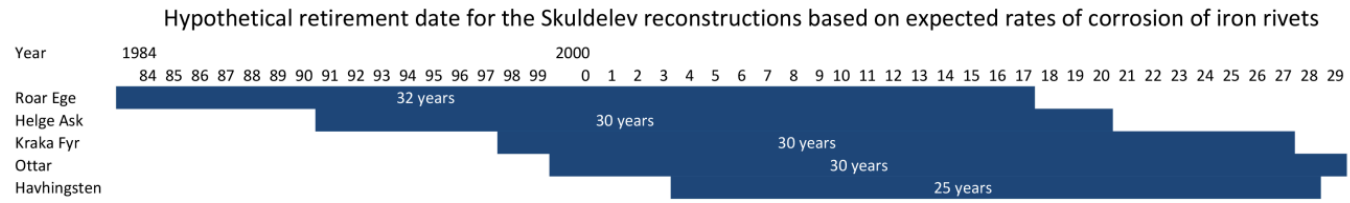
Roar Ege's retirement at 32 years of age gives us a benchmark against which to assess the hypothetical lifespan of the other Skuldelev ship reconstructions (See Figure 12). It also raises a number of issues concerning how and when to 'end' an experiment. With the benefit of hindsight, the authors would contend that the work carried out in 2014 could be seen as one repair too many. It's difficult to imagine that Viking Age boatbuilders – or boat owners, for that matter – would have invested so much time and so many resources in repairing such an aging vessel. They would most likely have split the hull apart, reused what they could and scrapped the rest.

FIG 12. ESTIMATED LIFE EXPECTANCY OF THE REMAINING SKULDELEV SHIP RECONSTRUCTIONS, AS CALCULATED BY BOATBUILDER, ASGER RØRDAM.

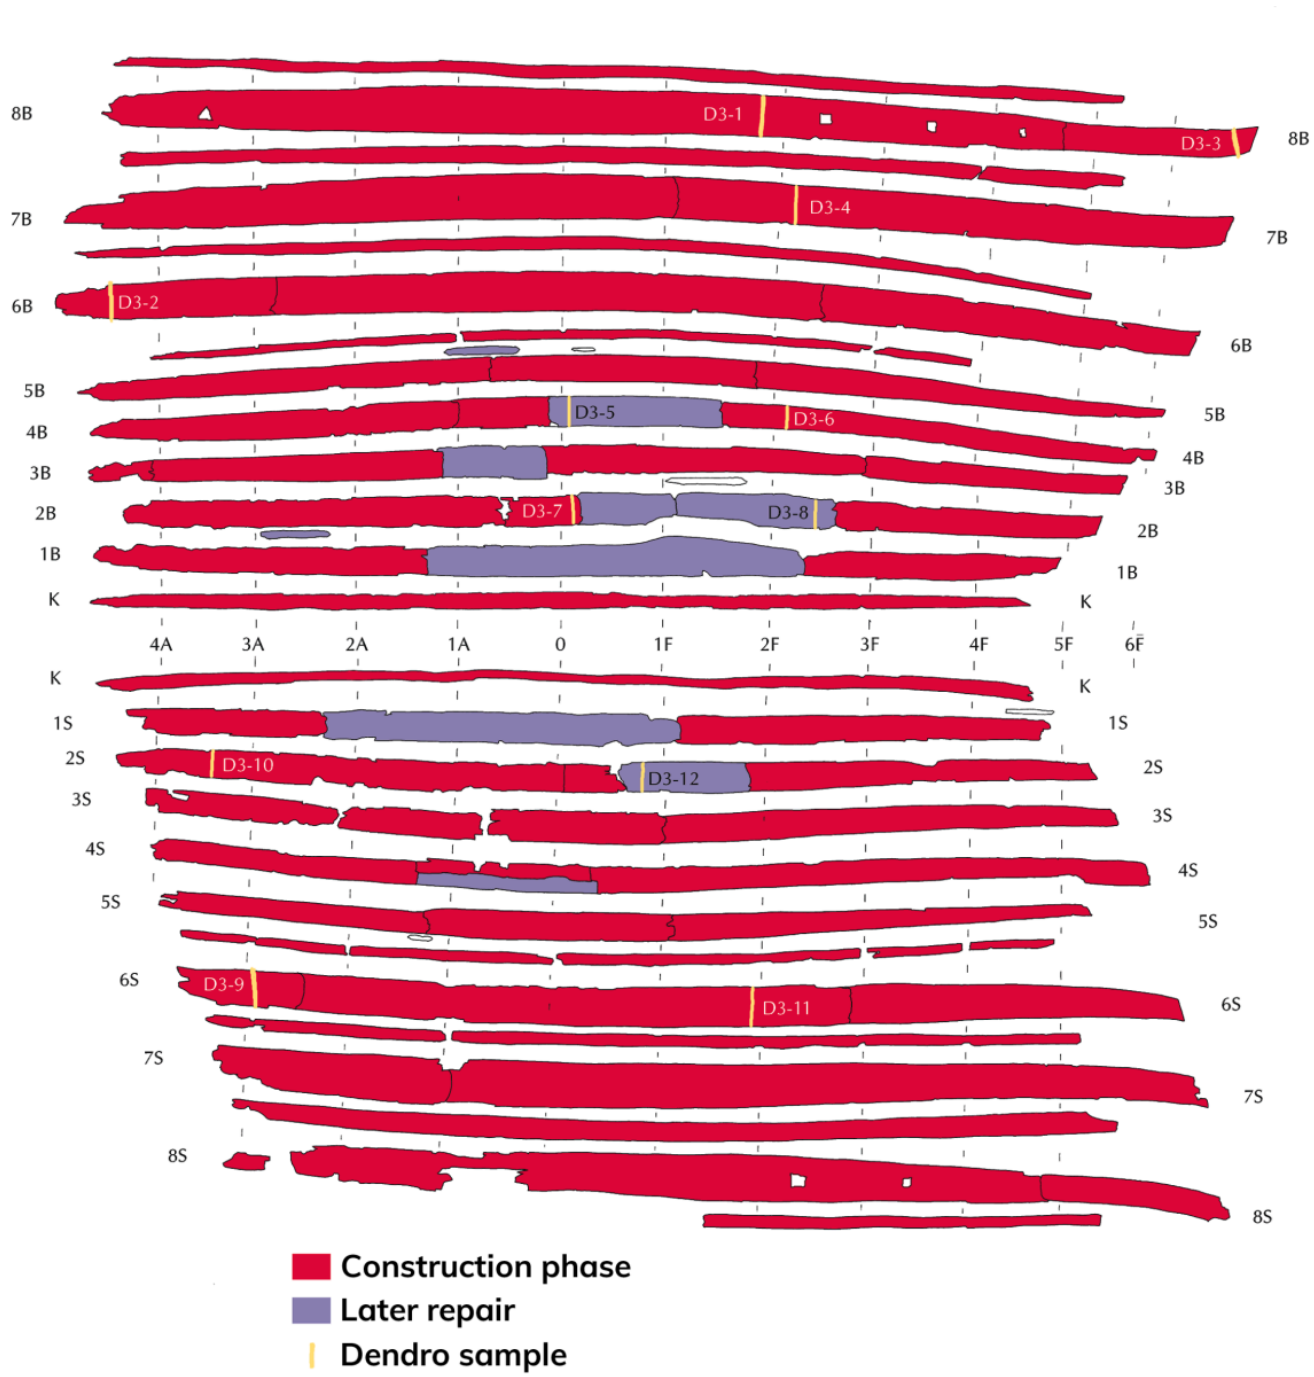
Skuldelev 3 is estimated to have been between twenty to thirty years old when it was scuttled at the barrier at Skuldelev (Crumlin-Pedersen and Olsen, 2002, p.333). This total tallies well with the 31 years *Roar Ege* had in active service. Skuldelev 3 had been repaired several times during its lifetime, with short sections of planking being replaced below the waterline (See Figure 13; Crumlin-Pedersen and Olsen, 2002, p.230). Strikingly, the situation with the sequence of repairs on *Roar Ege* can be seen as quite the opposite. Apart from the sheathing added in 2012 and the general deterioration of the lands in 2016, the majority of the repairs have been located above the waterline.

FIG 13. THE PLANKING OF SKULDELEV 3 WITH INDICATION OF REPAIRS MARKED IN PURPLE (AFTER CRUMLIN-PEDERSEN AND OLSEN 2002, 230, FIG. 41).
